### M8 FERMOY BYPASS BRIDGE, IRELAND - TF EXPANSION JOINT REPLACEMENT

Replacement of expansion joint - supply and installation of 1 no. 23m Ekspan TF 1300 expansion joint.

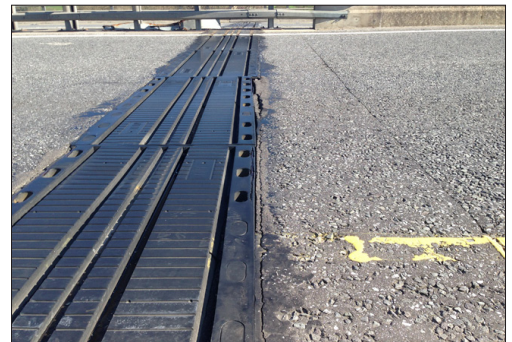
Following an in-depth independent investigation, requested by Direct Route, findings revealed the existing joints on the southern abutment in both directions had failed. Measurements and readings taken exposed considerable abnormal shrinkage and creep on the joints, and prestress had caused elastic shortening of the deck. The temperature differences and movement ranges had exceeded the capacity of the movement joint for this bridge, making the existing joints non-functional and proving these, through collated data, to be either an incorrect joint type or incorrectly installed. Direct Route required these joints renewing with a suitable joint system to accommodate the more than originally anticipated movement range for the M8 Fermoy Bypass.

USL Ekspan's inspection had also verified the failing of the south abutment expansion joints and their incapability to achieve the designed bridge movements or accommodate the bridge expansion gap between the deck and abutment ballast wall. This inadequacy had forced the joint fixings to rotate and shear due to the bridge's large thermal movements and the loads/speeds of vehicles travelling across. The joint was audible and sporadic bouncing was visible during transit. Eventually this would result in the joint lifting out of the road, creating a catastrophic hazard to motorists, especially motorbikes. The north abutment joints had deteriorated, not to the same extent, but also required maintenance as these too were likely to fail in the same way.

*Failed expansion joint - showing detachment from surface, delamination and joint exposure.*

USL Ekspan's programme of works was undertaken in three phases. These included removal of the south abutment joints; installation of the secondary seal and downpipes to suit the existing drainage arrangement and installation of one 23 m TF 1300 over both carriageways. Remedial works were carried out on the north abutment joints.

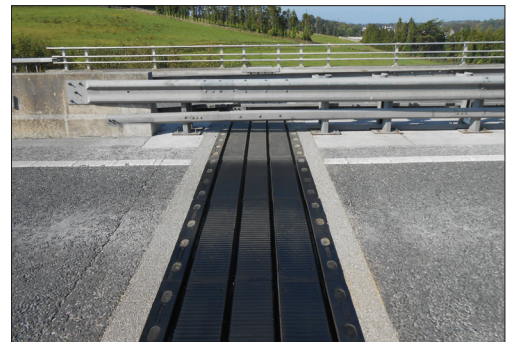
*New installed TF1300 expansion joint*

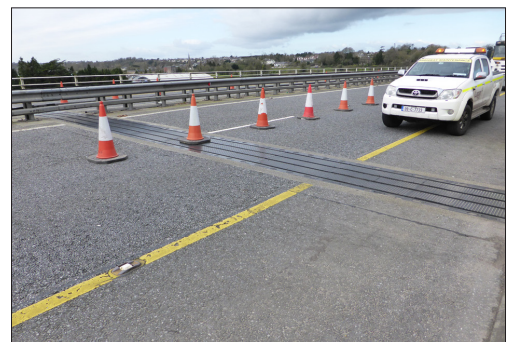
*Completion of replaced expansion joint*
