# Case Study - Bearings / Offshore

## WEST SOLE PLATFORM, WA-WAP LINK BRIDGE - BRIDGE JACKING & BEARING REPLACEMENT

**Scope:** Bearing supply, bridge jacking and bearing replacement works.

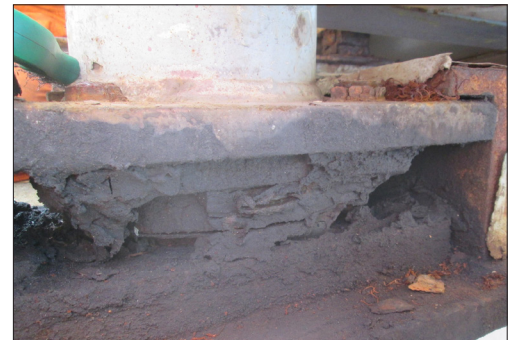
The existing bearings all appeared to be original PSC inverted mechanical pot bearings that had been supplied circa 1983. The findings revealed these bearings had reached the end of their design life and needed to be replaced. Excessive corrosion and debris to bearing fixings, uplift brackets and adjacent steelwork had caused stress on the bearings, which subsequently resulted in skew, between bridge and jacket structures inhibiting movement.

*Existing bearing prior to removal shows excessive corrosion*

Ekspan were appointed by Perenco to replace these mechanical bearings.

The inspection had confirmed a number of dimensional inaccuracies associated with the original bearings. The main dimensional differences related to the fixing hole centres and the overall base plate lengths for the WAP end bearings. Ekspan manufactured 4 no bespoke mechanical pot bearings (1 fixed and 3 guide) to suit the existing dimensions and load criteria. The sequential methodology for bearing replacement and careful monitoring throughout enabled successful completion of works while also maintaining restraint between the bridge and the platform.

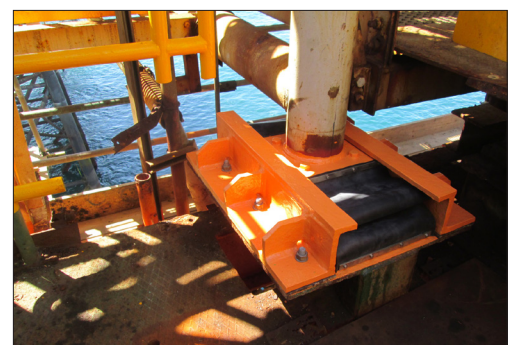
*Bearing replaced complete with protective cover*

To prolong the bearing life stainless steel slide plates were fully welded to the base plates, to prevent de-lamination. Protective rubber skirts were installed to protect the sliding surfaces and reduce the effects of debris ingress.
