### A689 RIVER EDEN BRIDGE, CARLISLE - CNDR BEARING REPLACEMENT & BRIDGE JACKING

Design, manufacture, installation of 3 no. free and 1 no. fixed pot bearings. Design and installation of temporary works and bridge jacking.

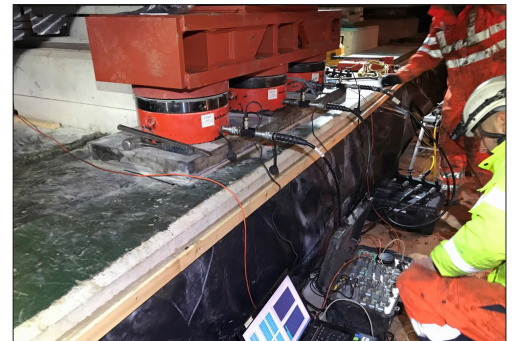
*Hydraulic jacking assembly digitally monitors and controls the bridge's movement during bearing removal and replacement.*

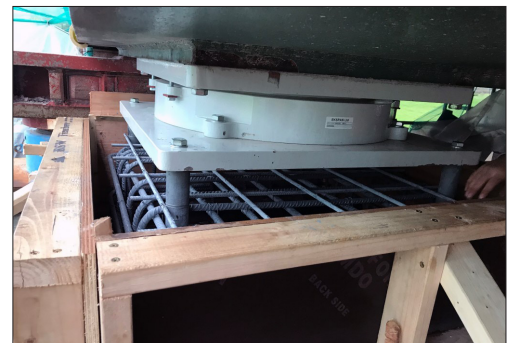
*Installation of steel rebar and shuttering in place to accept pouring of concrete for the new bearing plinth.*

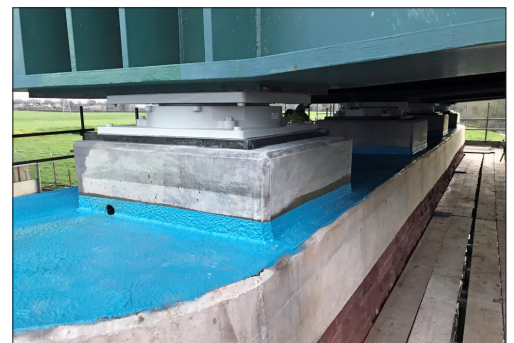
*New installed pot bearings on pier top with added concrete protection.*
