A40 GREENFORD ROUNDABOUT FLYOVER - TEMPORARY WORKS & BEARING REPLACEMENT

Temporary works and bridge jacking.
Design, manufacture and installation of 24 no. replacement free and guide spherical bearings.

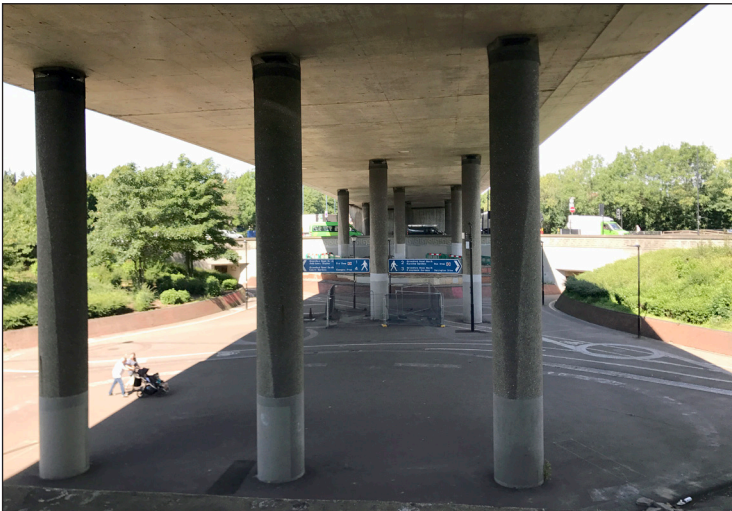
Greenford Flyover in west London, carries the dual three-lane carriageway A40 Westway Avenue over the A4127 Greenford Road roundabout. The bridge is a 7-span cast in-situ concrete structure, comprising of six sets of three intermediate circular columns. The bridge deck articulates on 24 no. spherical bearings - 3 no. are located on each abutment bearing shelf and 1 no. on top of each column.

The existing bearings, due to the ageing structure and its constant high traffic volumes entering London, were excessively worn. A bearing inspection carried out by USL Ekspan in 2014 highlighted similar findings as well as issues with the original bearing installation. USL Ekspan were contracted by FM Conway to deliver a full bearing replacement.

The bearing replacement for the support sets (3 columns per support) and abutments were undertaken in 3 phases. USL Ekspan's programme of works for each phase included: design and installation of temporary works; bridge jacking on the east and west abutments; installation of super props and jacking at the columns, enabling the bridge deck to be lifted 2mm, to allow hydro-demolition removal of the old bearings.

USL Ekspan designed and manufactured EN1337 compliant free and guided spherical bearings. Following installation of the new EN1337 bearings, the final process of works involved de-jacking the structure and removal of temporary works.

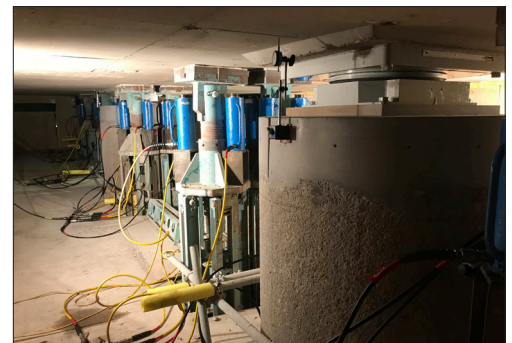
Temporary works and jacking of bridge column during bearing installation

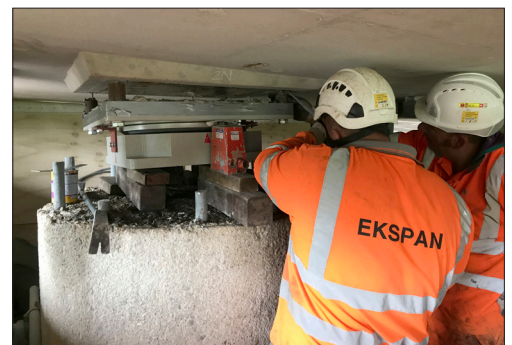
Bonding of top of bearing to the bridge structure

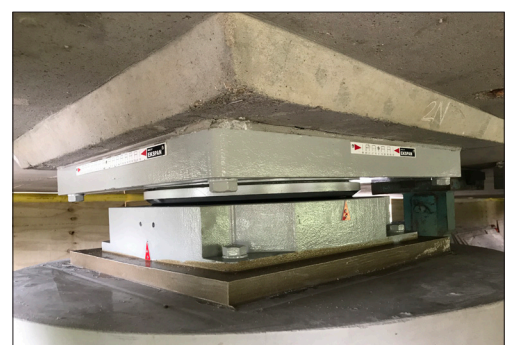
Spherical bearing installed
